# Manhole Inspection Summary

Manhole # S39E\_\_019MH

Insp Date: **1/15/08 2:07 PM**

**Location** Address: **n.exeter st**

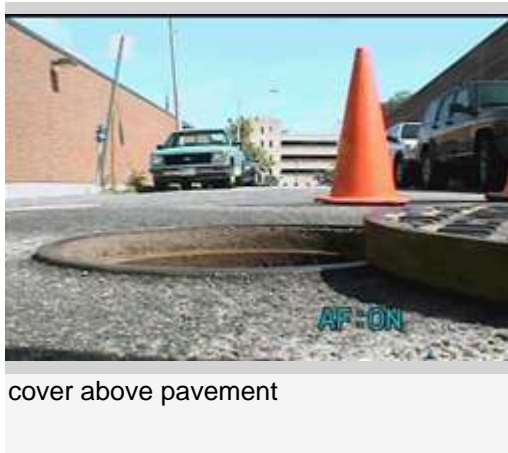
Miscellaneous

cover above pavement

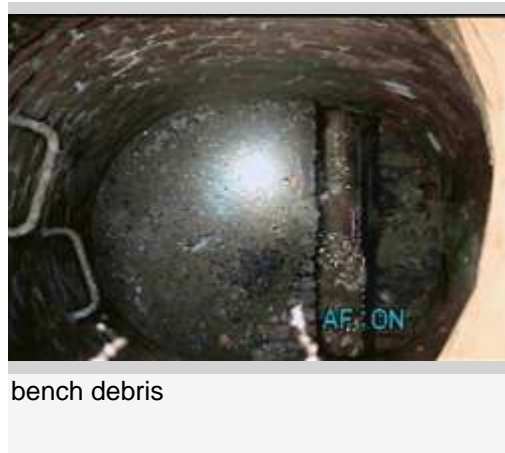
Defect 5

Condition: ☐ Sound ☐ Cracked ☐ Root Intrusion ☐ Deteriorated ☐ Leaks ☒ **Debris**

bench debris

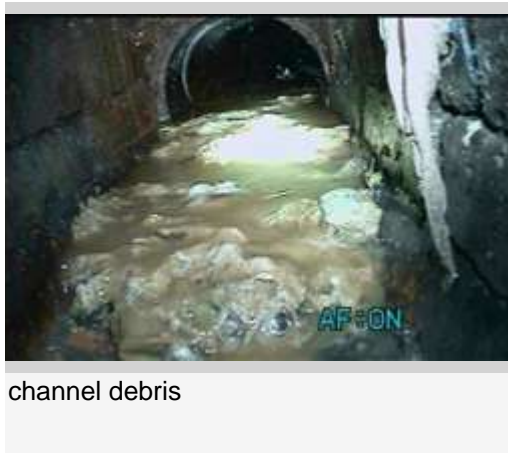
Defect 3

Condition: ☐ Sound ☐ Cracked ☐ Root Intrusion ☐ Deteriorated ☐ Leaks ☒ **Debris**

channel debris

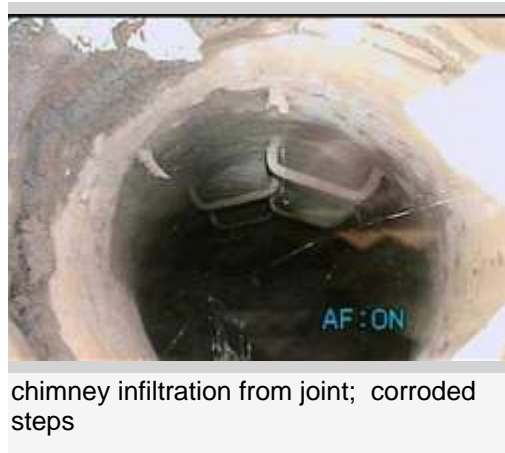
Defect 2

Infiltration: ☐ None ☒ **Joint** ☐ Cracks ☐ Mortar ☐ Roots ☐ Wall

**Steps** Count: **5** Missing: **1** ☒ **Corroded**

chimney infiltration from joint; corroded steps

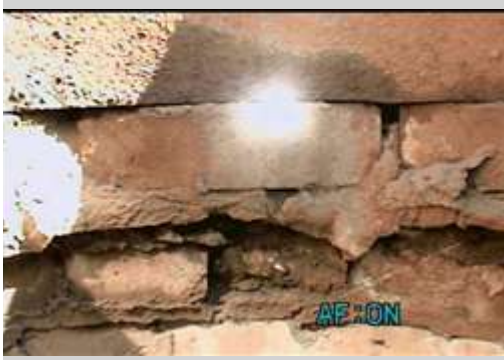
## Defect 1

Condition: ☐ Sound ☐ Cracked ☐ Root Intrusion ☒ **Loose Brick** ☒ **Deteriorated**

chimney is deteriorated with loose bricks

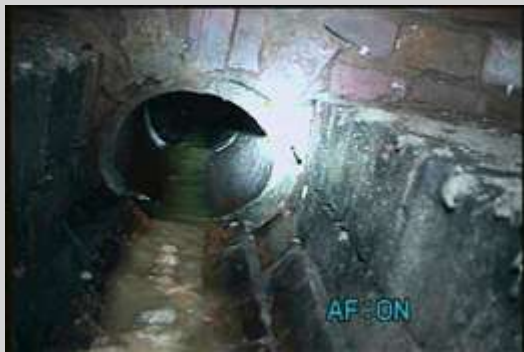
12 O'Clock Outflow

8 in. Circular Gravity Sewer  
Pipe Out @ 12 O'Clock

Invert Depth: 9.90 (ft.) Flow Characteristics: **None**

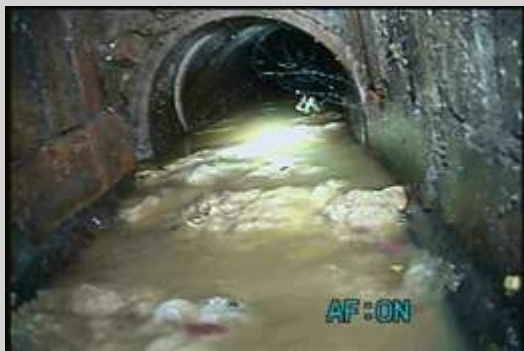
6 O'Clock Inflow

8 in. Circular Gravity Sewer  
Pipe In @ 6 O'Clock

Deposits: ☐ None ☐ Mud ☐ Sludge ☒ **Debris** ☐ Grease

Silt Depth: 1 (in.) Deposits Extent: **Medium**
